Quality Assurance and Source Inspection

Contract #: 04-0120F4Cty: SF/ALA Rte: 80 PM: 13.2/13.9File #: 69.28**WELDING INSPECTION REPORT****Resident Engineer:**Pursell, Gary**Address:** 333 Burma Road**City:** Oakland, CA 94607**Report No:** WIR-015011**Date Inspected:** 18-Jun-2010**Project Name:** SAS Superstructure**OSM Arrival Time:** 700**Prime Contractor:** American Bridge/Fluor Enterprises, a JV**OSM Departure Time:** 1900**Contractor:** Zhenhua Port Machinery Company, Ltd (ZPMC), Changxing Island **Location:** Shanghai, China**CWI Name:** Xu Tao**CWI Present:** Yes No**Inspected CWI report:** Yes No N/A**Rod Oven in Use:** Yes No N/A**Electrode to specification:** Yes No N/A**Weld Procedures Followed:** Yes No N/A**Qualified Welders:** Yes No N/A**Verified Joint Fit-up:** Yes No N/A**Approved Drawings:** Yes No N/A**Approved WPS:** Yes No N/A**Delayed / Cancelled:** Yes No N/A**Bridge No:** 34-0006**Component:** OBG COMPONENT**Summary of Items Observed:**

WELDING INSPECTION REPORT

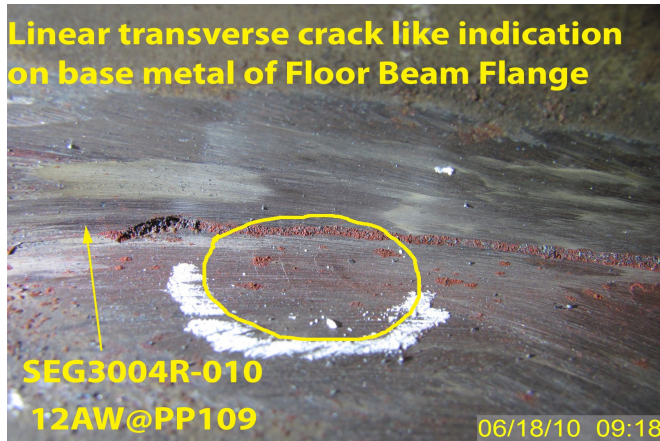
During random visual inspection at segment 12AW on Panel Point PP109, the QA Inspector found the linear transverse crack like indication on several locations at the base metal of Floor beam flange .The mention area was not welded due to tack weld crack at bay #14. Then the QA Inspector informed to ZPMC QC Personnel to perform Magnetic Particle Testing at mention area and more than 90% of the crack tack area found linear transverse indication on base metal of Floor Beam Flange.The QA inspector informed to ZPMC QC Mr. Li Ping and ABF QA Mr. Wen Jian Bao to remove the indication and do Magnetic Particle Testing for confirmation at those mention area. For more information see the attached photo.

Linear transverse crack like indication
on base metal of Floor Beam Flange

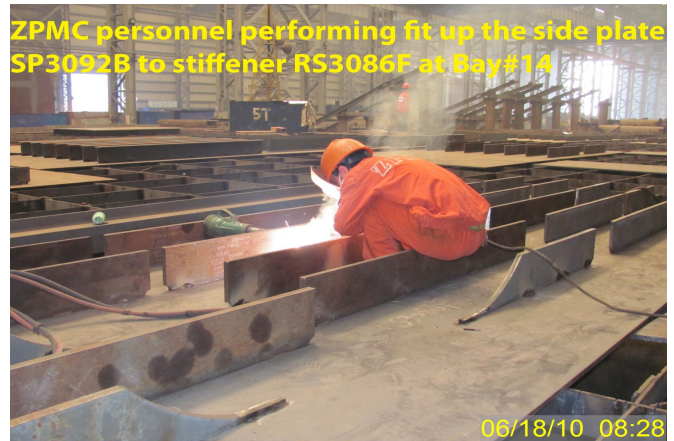
ZPMC personnel performing fit up the side plate
SP3092B to stiffener RS3086F at Bay#14

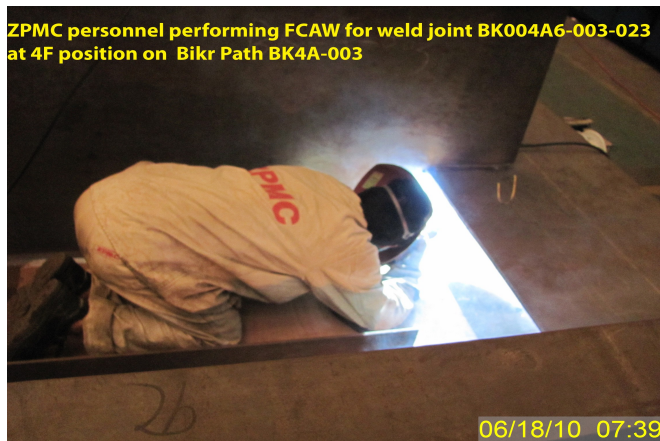
FCAW in the 4F position for the OBG Bike Path BK004A weld No. BK004A6-003-023/024. The welder is identified as #500909. ZPMC QC is identified as Mr. Zhoe Chang. The welding variables recorded by QC appear to comply with WPS-B-T-2134.

ZPMC personnel performing FCAW for weld joint BK004A6-003-023
at 4F position on Bkr Path BK4A-003

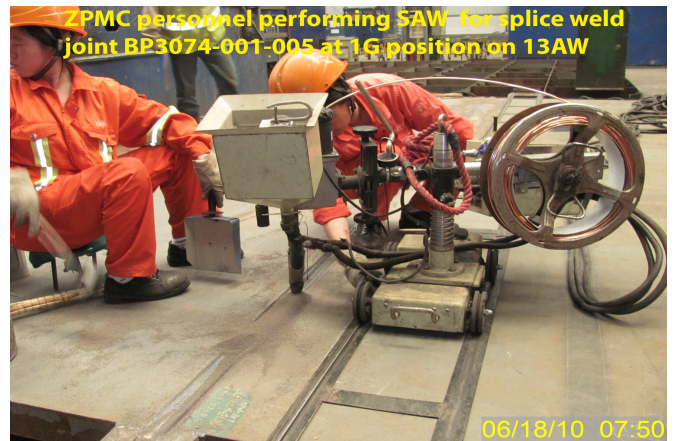
SAW in the 1G position for the OBG Segment 13AW bottom Plate, weld No. BP3074-001-005. The welder is identified as #045265. ZPMC QC is identified as Mr. Xia Chan Hui. The welding variables recorded by QC appear to comply with WPS-B-T-2221-B-U3c-S-2.

ZPMC personnel performing SAW for splice weld
joint BP3074-001-005 at 1G position on 13AW

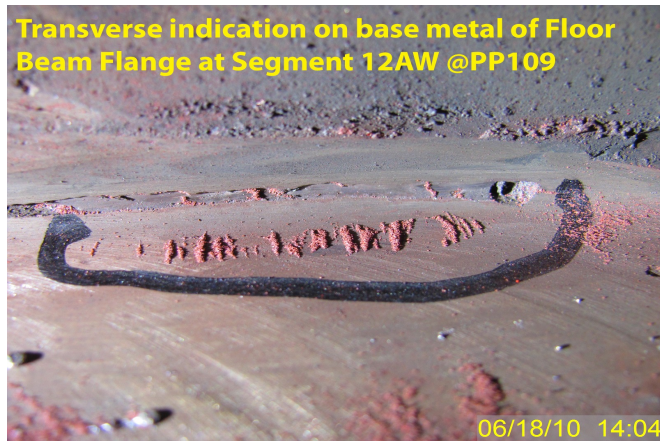
Transverse indication on base metal of Floor
Beam Flange at Segment 12AW @PP109
